2008-01-03 Pbar Department Meeting

Thursday, January 03, 2008
9:59 AM

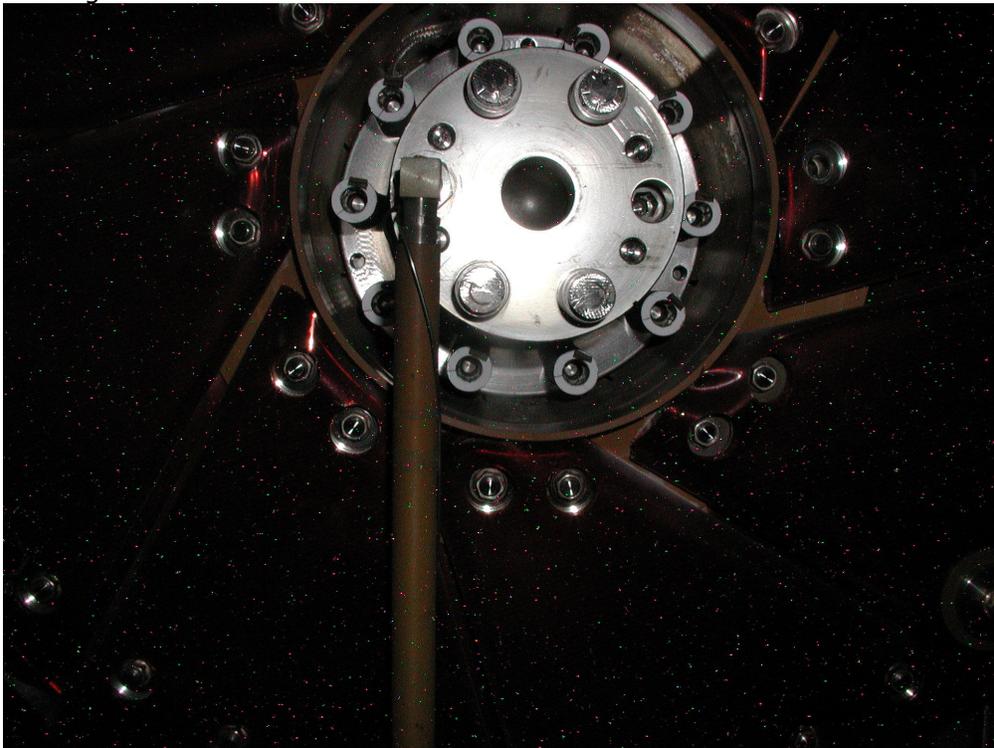
- When changing target, took pictures. It was noticed that a connecting bolt on the lens was missing

-
- So, next day, installed 10mm-3.

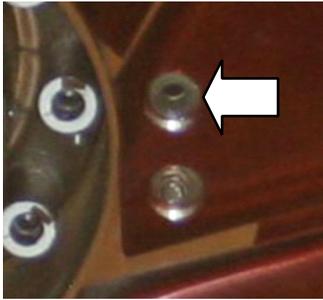
Missing bold at 2:00

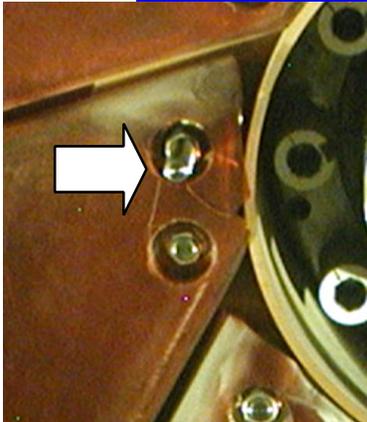
- Other side of lens, noticed that the tie-rod nut on the DS side has actually advanced onto the tie-rod and not fall off as occurred on the US side.
