Performance

The issue

- Lens
- 10mm-3

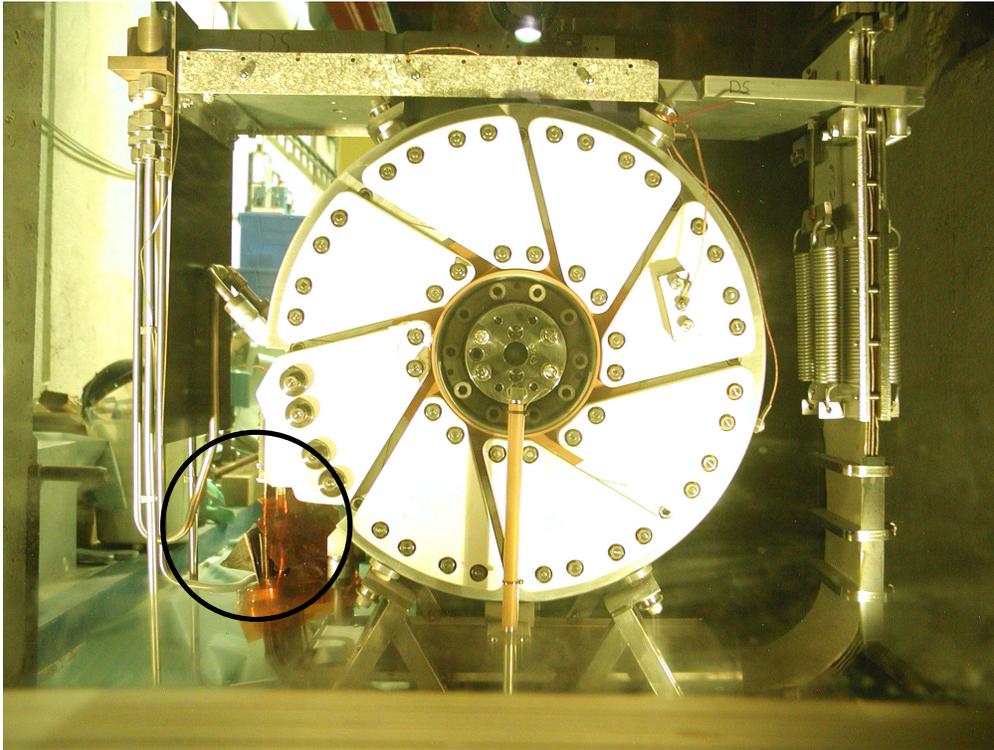
Failure location circled.

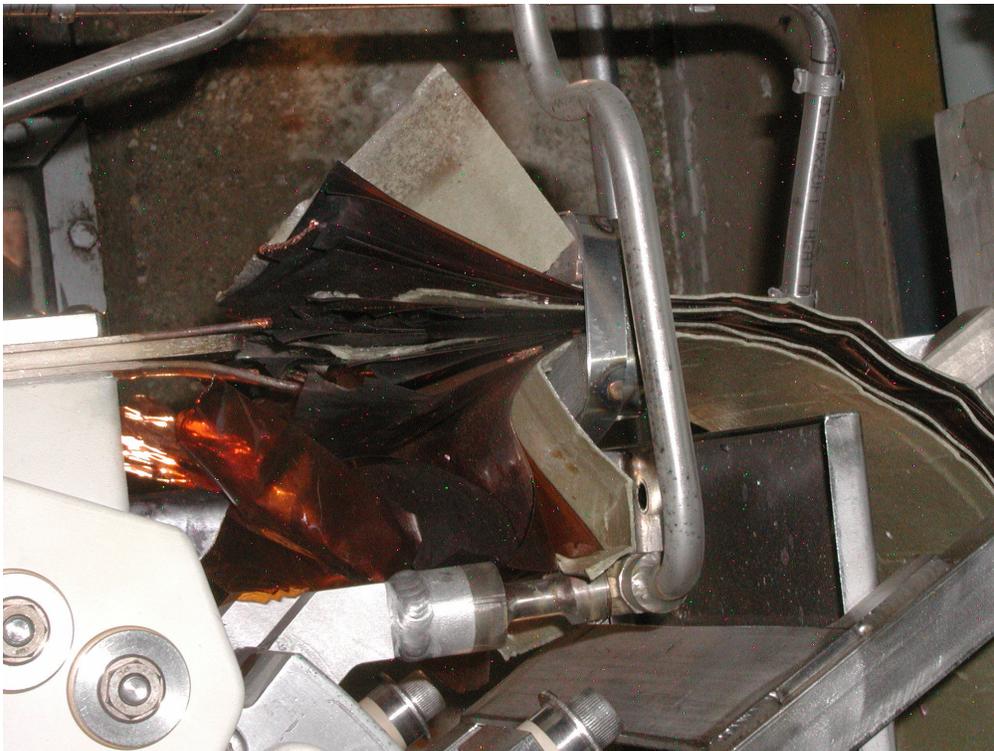
- Blowup of failure.
  - 180R/ft one side
  - 90R/ft other side
- Want to try to recover transformer.
- Water line connection - VCR - found that 10mm-2 was leaking water when it was in service.
- Then....
- Put in 10mm-2
  - Some problems.

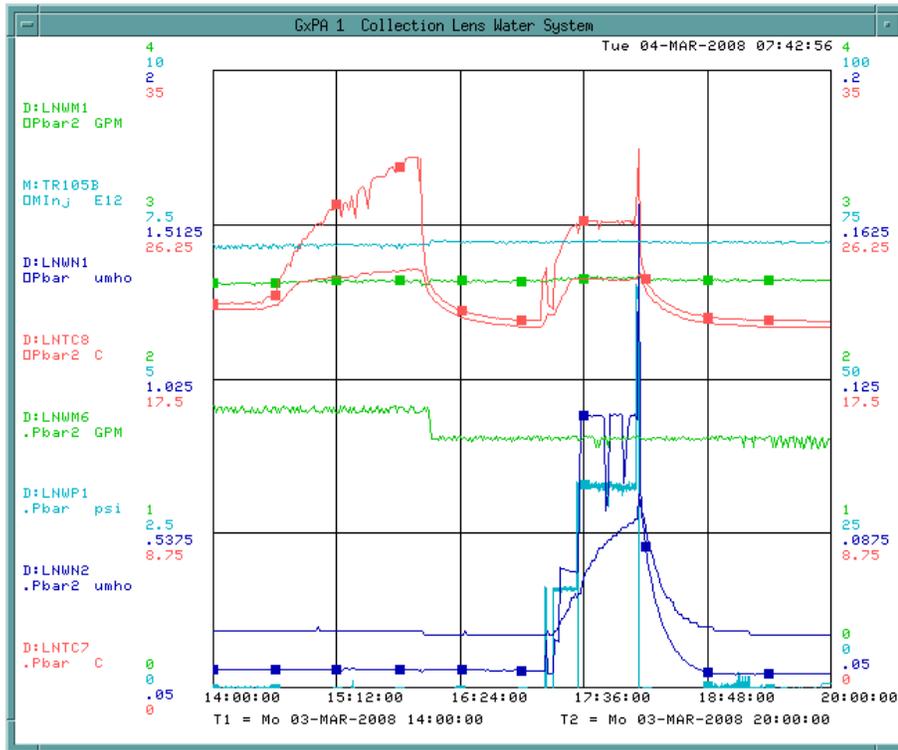
Apparent Li breach on 10mm-2

That led to another lens changout...

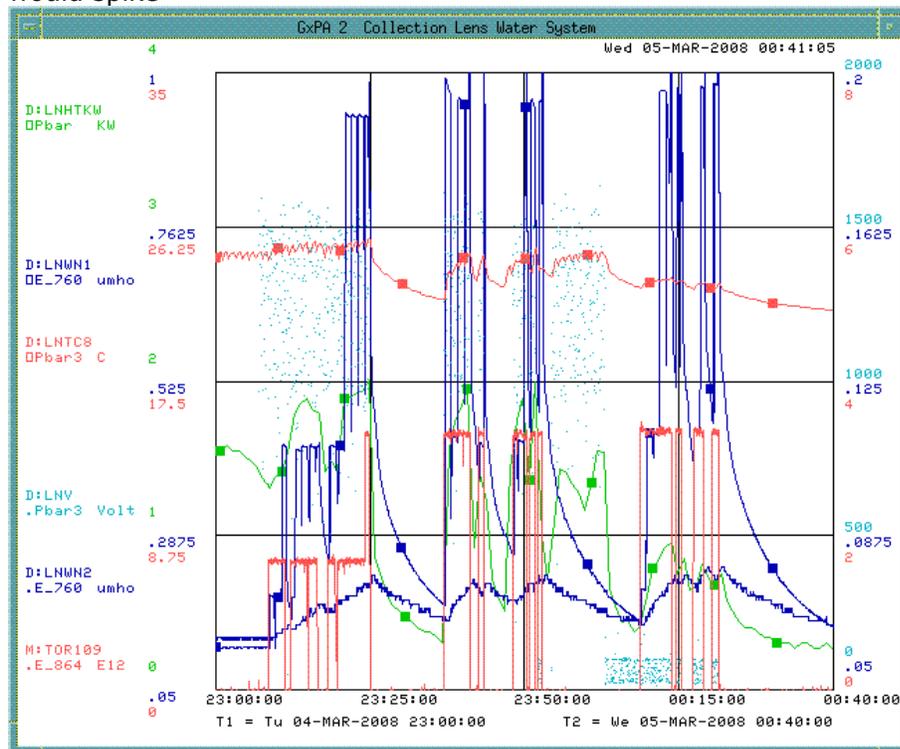
- Steel body lens 32 had the same problem.
- Pulse at full gradient, same conductivity, But when ran beam, conductivity would spike

- Ran overnight at low gradient and beam on target.

- Water contaminated?
- Next would go to Lens 23. Has record number of pulses
- New lens
- Recover 10mm-3
- Maybe recover 10mm-1...had a transformer ground fault. Has 6 million pulses on it. Was 80R on contact a few weeks ago.
