2009-10-06 A3B7 Failing

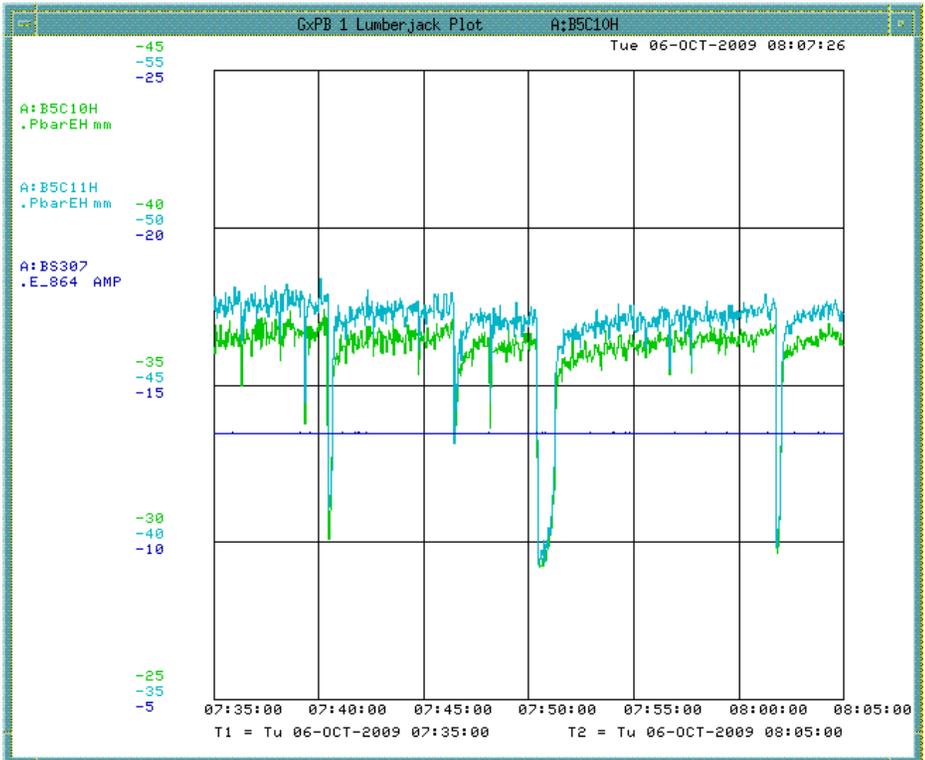
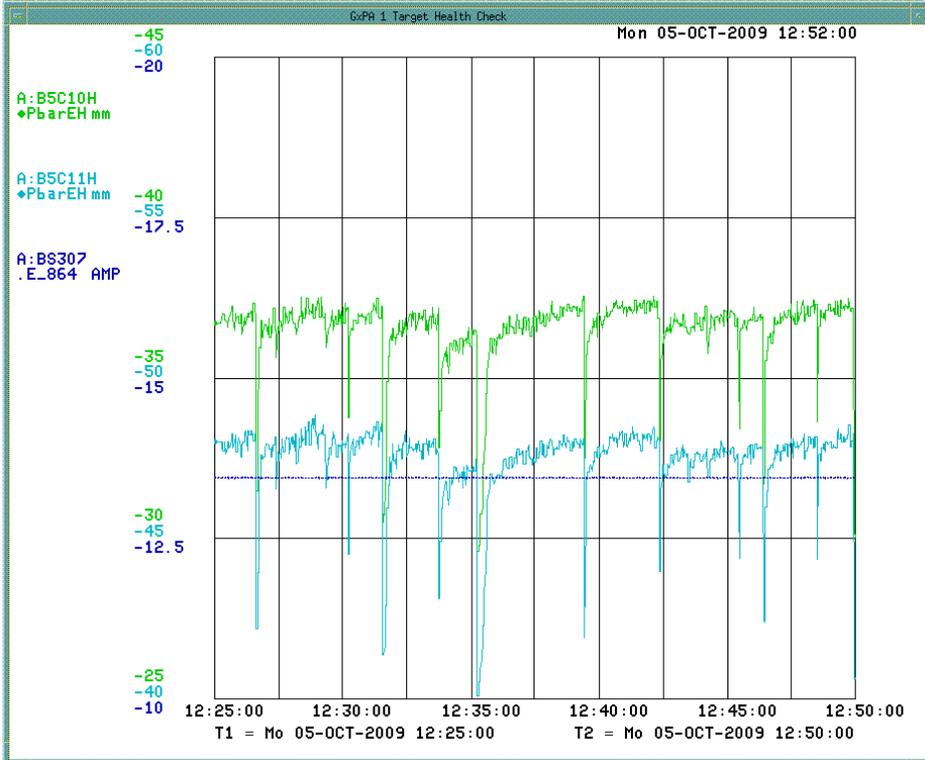
- A3B7

- Inductance testing showed that magnet is bad
 - Normally is 24.7mH at 1KHz
 - Now is 6mH at 1 KHz
- Impact on stacking
 - Not much.

- Impact on transfers
 - Some transfers there is a orbit offset, and transfer efficiency down to 80% if that happens.
- A4B7 was replaced in 1995
 - Was ground faulted and repaired
