# 2010-05-20 Thursday Morning Notes

Thursday, May 20, 2010  
7:00 AM

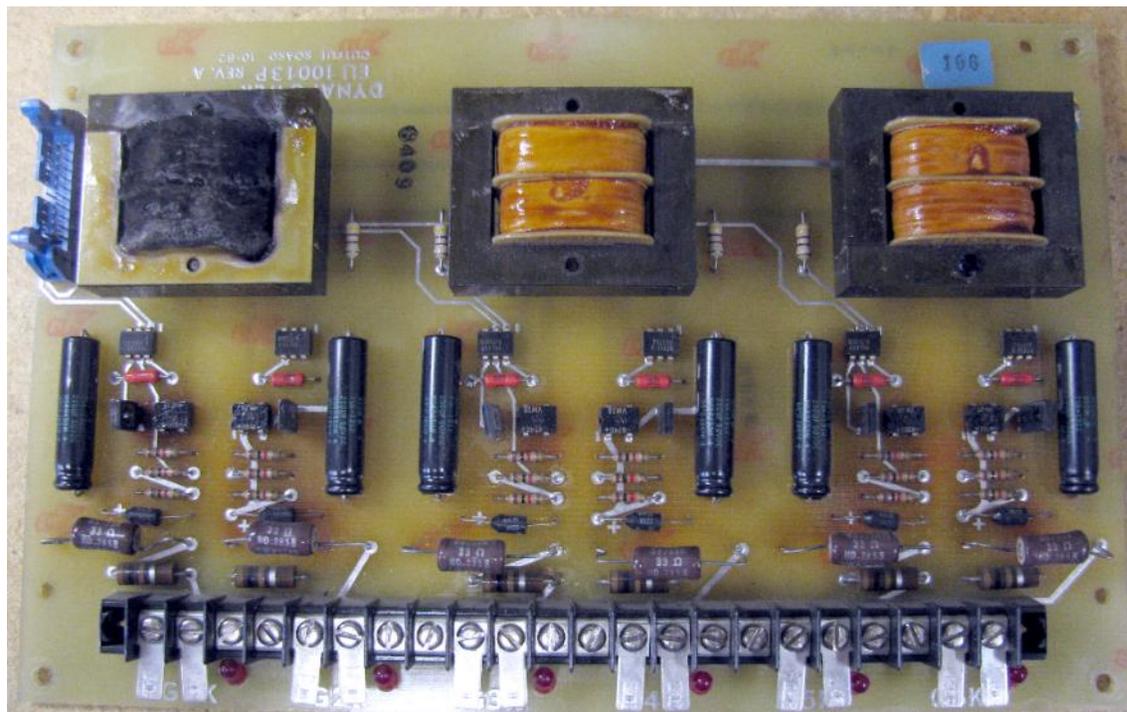
- He also found another bad board in M:Q107 and replaced it.
- **Notes from Bernie**
  - **M:Q105I** - Yesterday the top SCR Gate Firing board was replaced, because 2 out of its 6 SCRs were not firing. Today the top SCR Gate Firing board was replaced, because 2 different SCRs were not firing due to a burnt transformer.

- **M:Q107** - Yesterday the top and bottom SCR Gate Firing boards were replaced, because 5 out of 12 SCRs were not firing. Today the top SCR Gate Firing board was replaced, because 2 SCRs were not firing due to a overheated transformer.

160
120
120
12
A: IBEAM
.RunCo mA 140
105
105
10.5
M: Q105RP
oPbar3 AMPS 120
90
90
9
M: Q107RP
oPbar3 Amps 100
75
75
7.5
M: TR105B
.E_864 E12
80
60
60
6
45
45
4.5
40
38
30
30
3
20
15
1.5
0
0
0
0

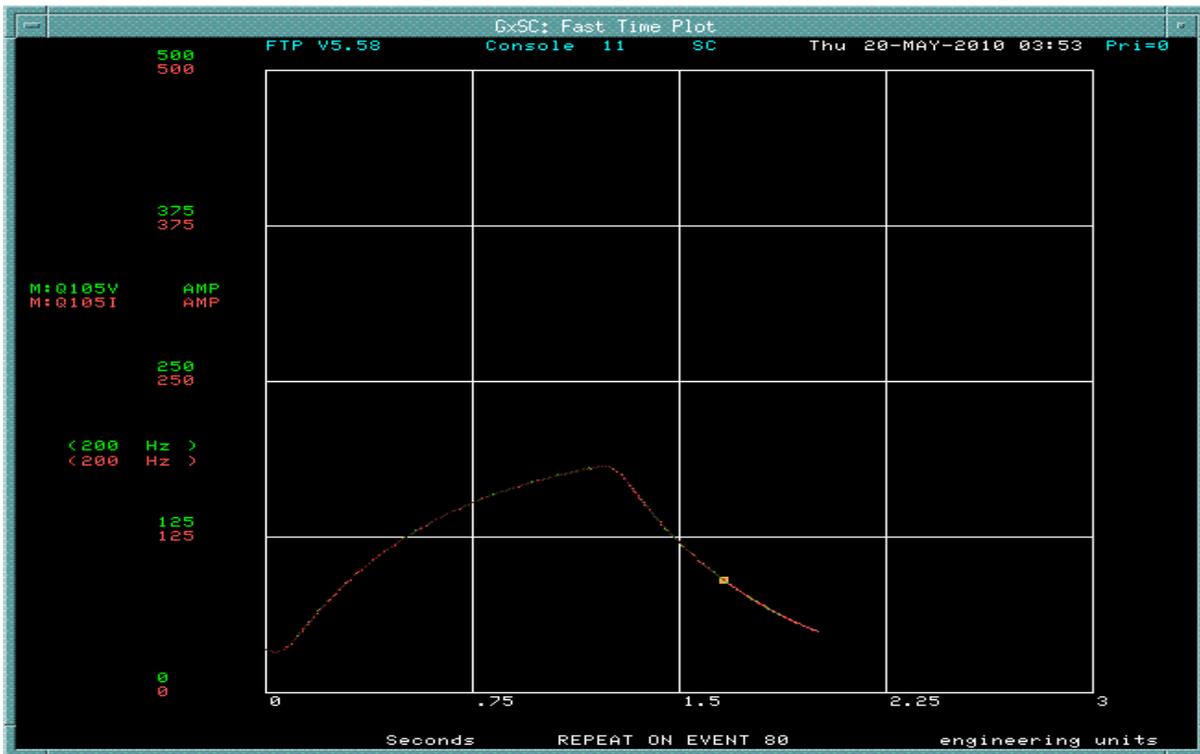
PA S53 DIGITAL STATUS

- On the owl shift M:Q105I started tripping on phase imbalance and the waveform was sloped at flattop.
  - Bernie came in and replaced the Gate Firing board again.

M:Q105I PQ5A&B 500A/100V QUAD -See Alarm Log-

CONTROL POWER	ON	1	0	*On
LOCAL/REMOTE CONTROL	LOCAL	0	0	*Off < *
GROUND FAULT	NO	1	0	*Reset< T
EXTERNAL REFERENCE	PRESENT	1	0	.....
DOOR INTERLOCKS	OK	1	0	.....
SCR TEMPERATURE	NORMAL	1	0	Local L
TRANSF. TEMPERATURE	NORMAL	1	0	Alarm is
P.S. WATER TEMPERATURE	NORMAL	1	0	ALARMING
PHASE UNBALANCE	TROUBLE	1	0	Speech is
DC OVER CURRENT	OK	0	0	BYPASSED
SAFETY SYSTEM INTERLOCK	OK	1	0	Edit
MAGNET TEMPERATURE	NORMAL	1	0	
15V P.S. NORMAL	OK	1	0	
EXTERNAL INTERLOCKS	OK	1	0	
INTERLOCKS COMPLETE	OPEN	0	0	
DC ON/OFF	OFF	0	0
