2010-10-29 Friday Morning Notes

Thursday, October 28, 2010

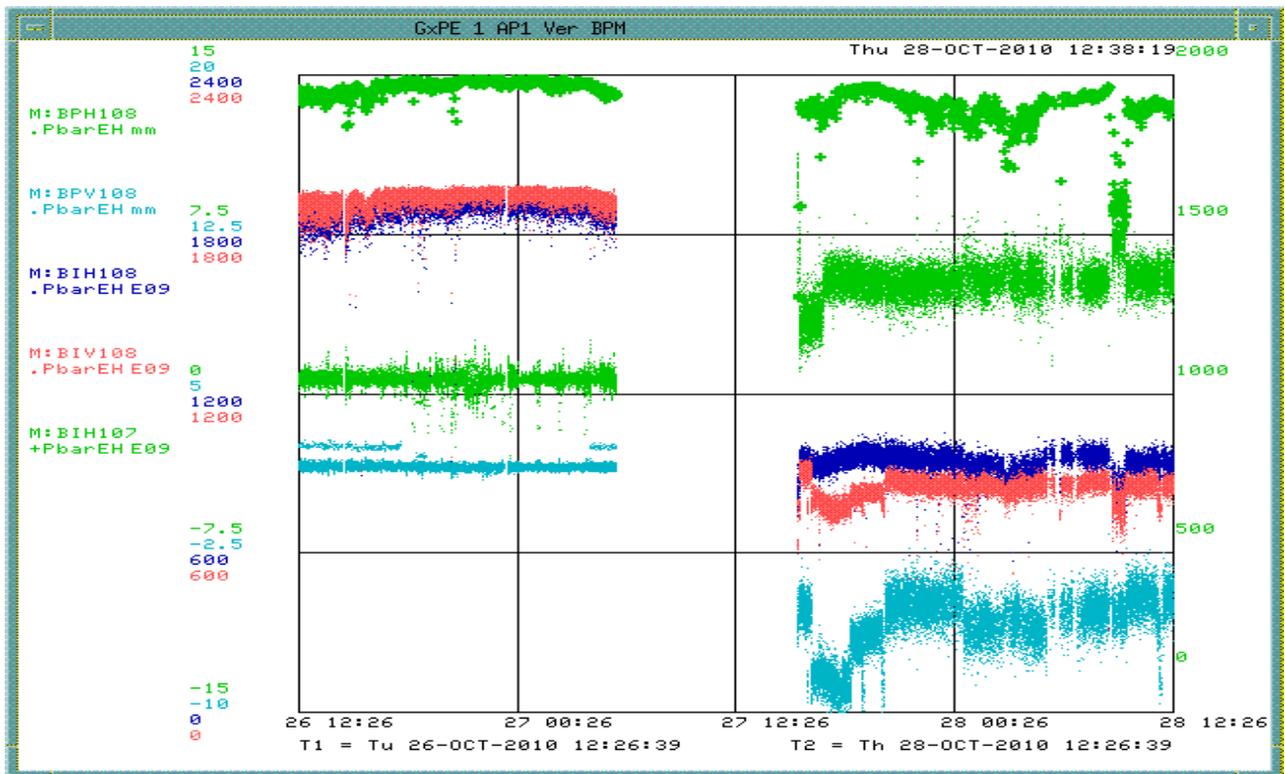
- Looking into issues
 - The 204 permit was pulled a couple of times on AP1 line vertical trims VT101 and VT11A.
 - BPM downstream of the new vacuum window behaves differently. This was causing the overthruer to have problems with correcting the orbit.

AP1 BPM at 108 is behaving differently after installation of the titanium vacuum window upstream of vt108 trim.

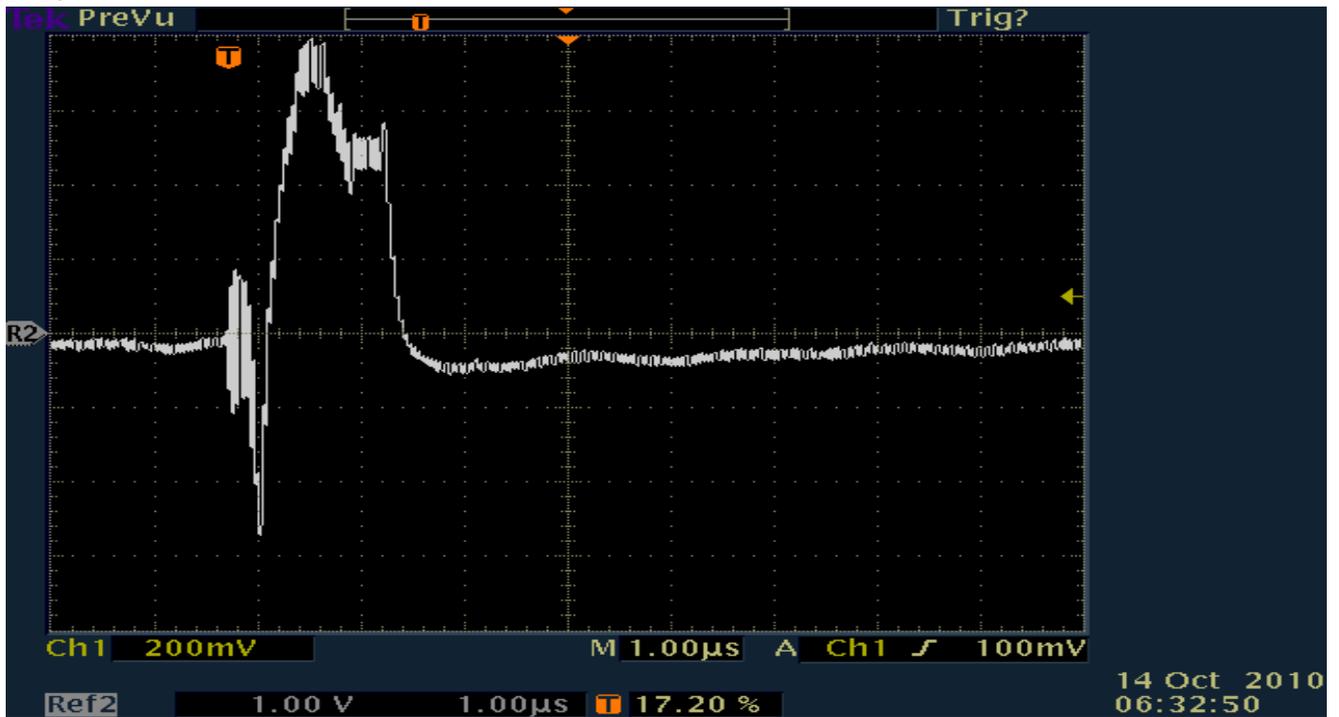
- It was found that the BPM has a large noise spike from sweeping. Moving sweeping timing does not change the BPM position.
 - The BPM might be able to be brought back to normal operation by the addition of a band pass filter. This is possible since BPM108 only is 53MHz. If it also were needed at 2.5MHz for transfers, this wouldn't work.

BV108, big signal from sweeping magnet

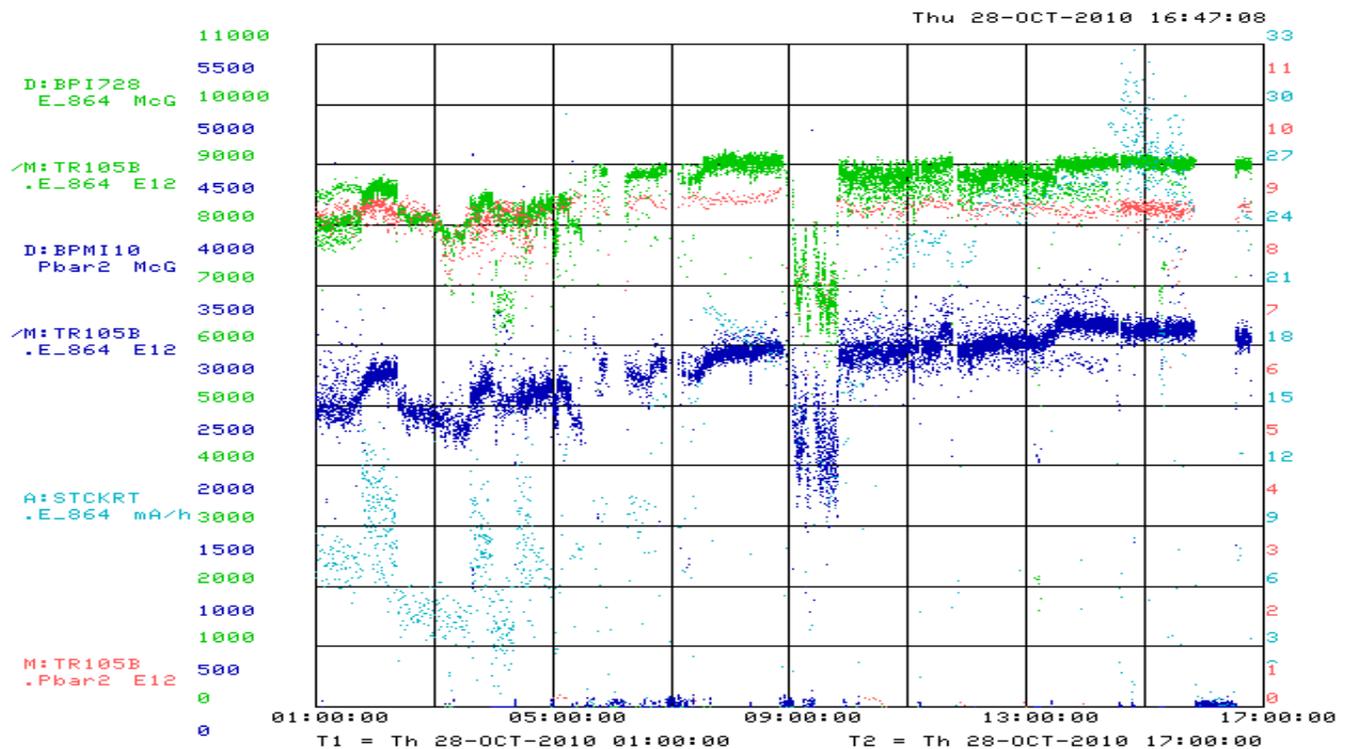
- M:Tor109 reads too high.
- We have good BPM coverage in the AP1 so we were able to mask BPM108 in both planes and the overthruer was able resume normal corrections.

After masking BPMH108 and BPMV108, overthruster is behaving.
