2008-01-03 Pbar Department Meeting

Thursday, January 03, 2008
9:59 AM

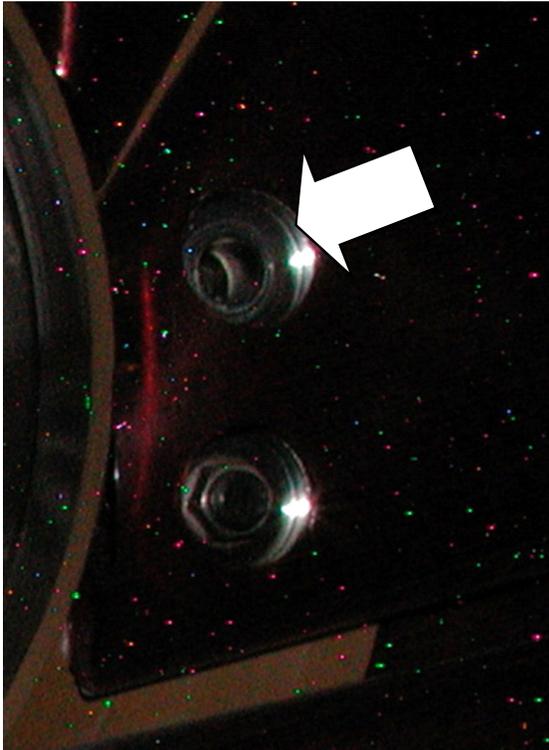
- When changing target, took pictures. It was noticed that a connecting bolt on the lens was missing

-
- So, next day, installed 10mm-3.

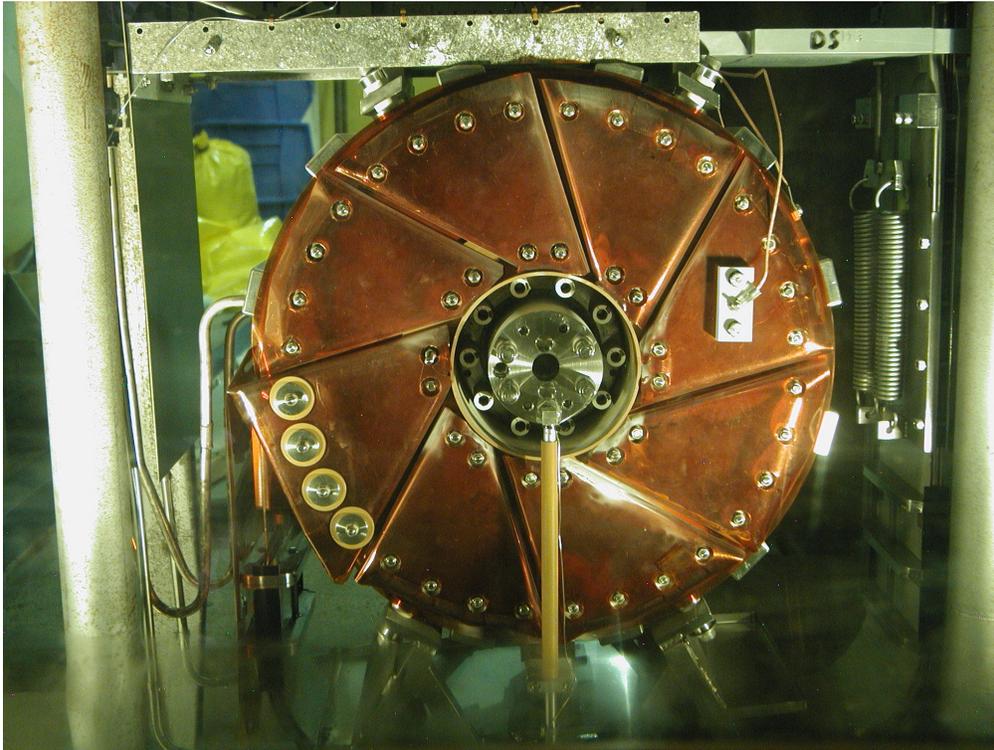
Missing bold at 2:00

- Picture from alcove.
