Performance

The issue

- Lens
- 10mm-3

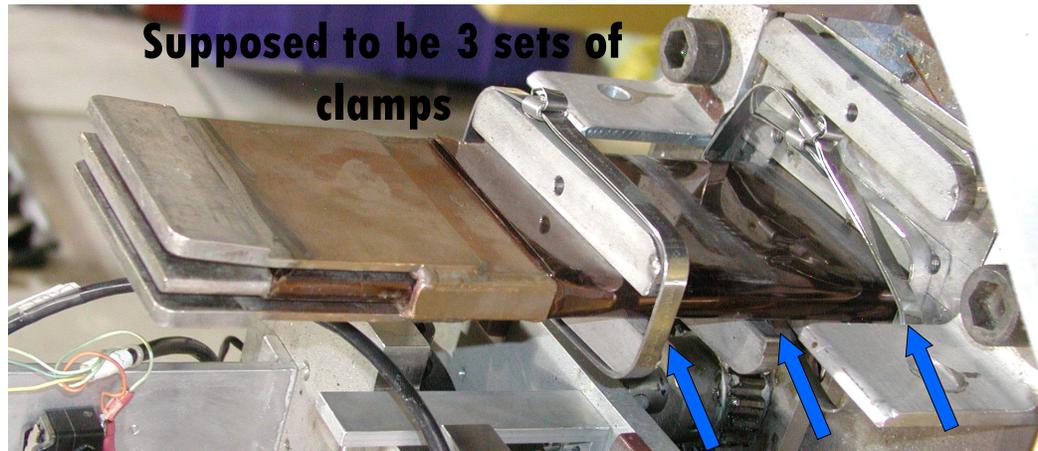
Failure location circled.

- Blowup of failure.
  - 180R/ft one side
  - 90R/ft other side
- Want to try to recover transformer.
- Water line connection - VCR - found that 10mm-2 was leaking water when it was in service.
- Then....
- Put in 10mm-2
  - Some problems.
