# 2010-05-20 Thursday Morning Notes

Thursday, May 20, 2010  
7:00 AM

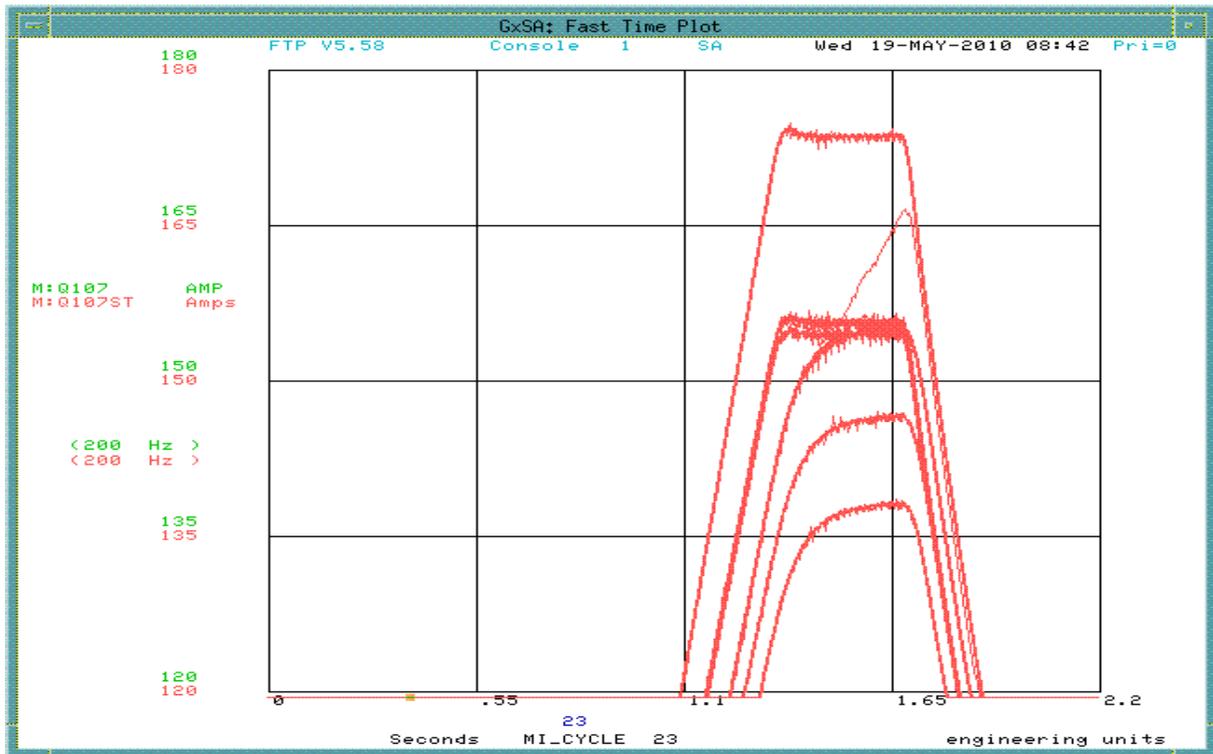
- On the owl shift M:Q105I started tripping on phase imbalance and the waveform was sloped at flattop.
  - Bernie came in and replaced the Gate Firing board again.

160
120
120
12
A: IBEAM
.RunCo mA 140
105
105
10.5
M: Q105RP
oPbar3 AMPS 120
90
90
9
M: Q107RP
oPbar3 Amps 100
75
75
7.5
M: TR105B
.E_864 E12
80
60
60
6
45
45
4.5
40
38
30
30
3
20
15
1.5
0
0
0
0

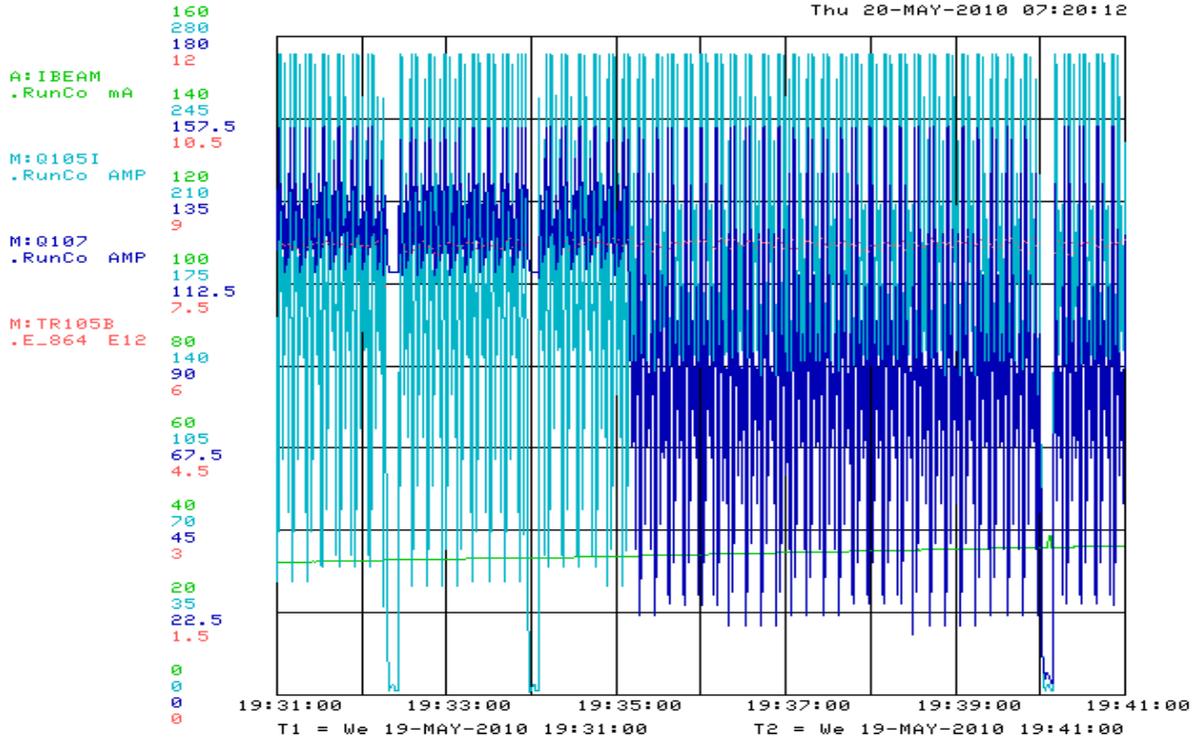
PA S53 DIGITAL STATUS

M:Q105I PQ5A&B 500A/100V QUAD -See Alarm Log-

CONTROL POWER	ON	1	0	*On
LOCAL/REMOTE CONTROL	LOCAL	0	0	*Off < *
GROUND FAULT	NO	1	0	*Reset< T
EXTERNAL REFERENCE	PRESENT	1	0	.....
DOOR INTERLOCKS	OK	1	0	.....
SCR TEMPERATURE	NORMAL	1	0	Local L
TRANSF. TEMPERATURE	NORMAL	1	0	Alarm is
P.S. WATER TEMPERATURE	NORMAL	1	0	ALARMING
PHASE UNBALANCE	TROUBLE	1	0	Speech is
DC OVER CURRENT	OK	0	0	BYPASSED
SAFETY SYSTEM INTERLOCK	OK	1	0	Edit
MAGNET TEMPERATURE	NORMAL	1	0	
15V P.S. NORMAL	OK	1	0	
EXTERNAL INTERLOCKS	OK	1	0	
INTERLOCKS COMPLETE	OPEN	0	0	
DC ON/OFF	OFF	0	0
